BUREAU OF LAND MANAGEMENT

RE: Minor Modification to the Skyline Mine No. 3 - Relocating Setup Room and Bleeder Entries for the 5th Right Longwall Panel

UTAH FUEL COMPANY
SKYLINE MINE No. 3
LOWER O'CONNOR-A SEAM
Original Plan

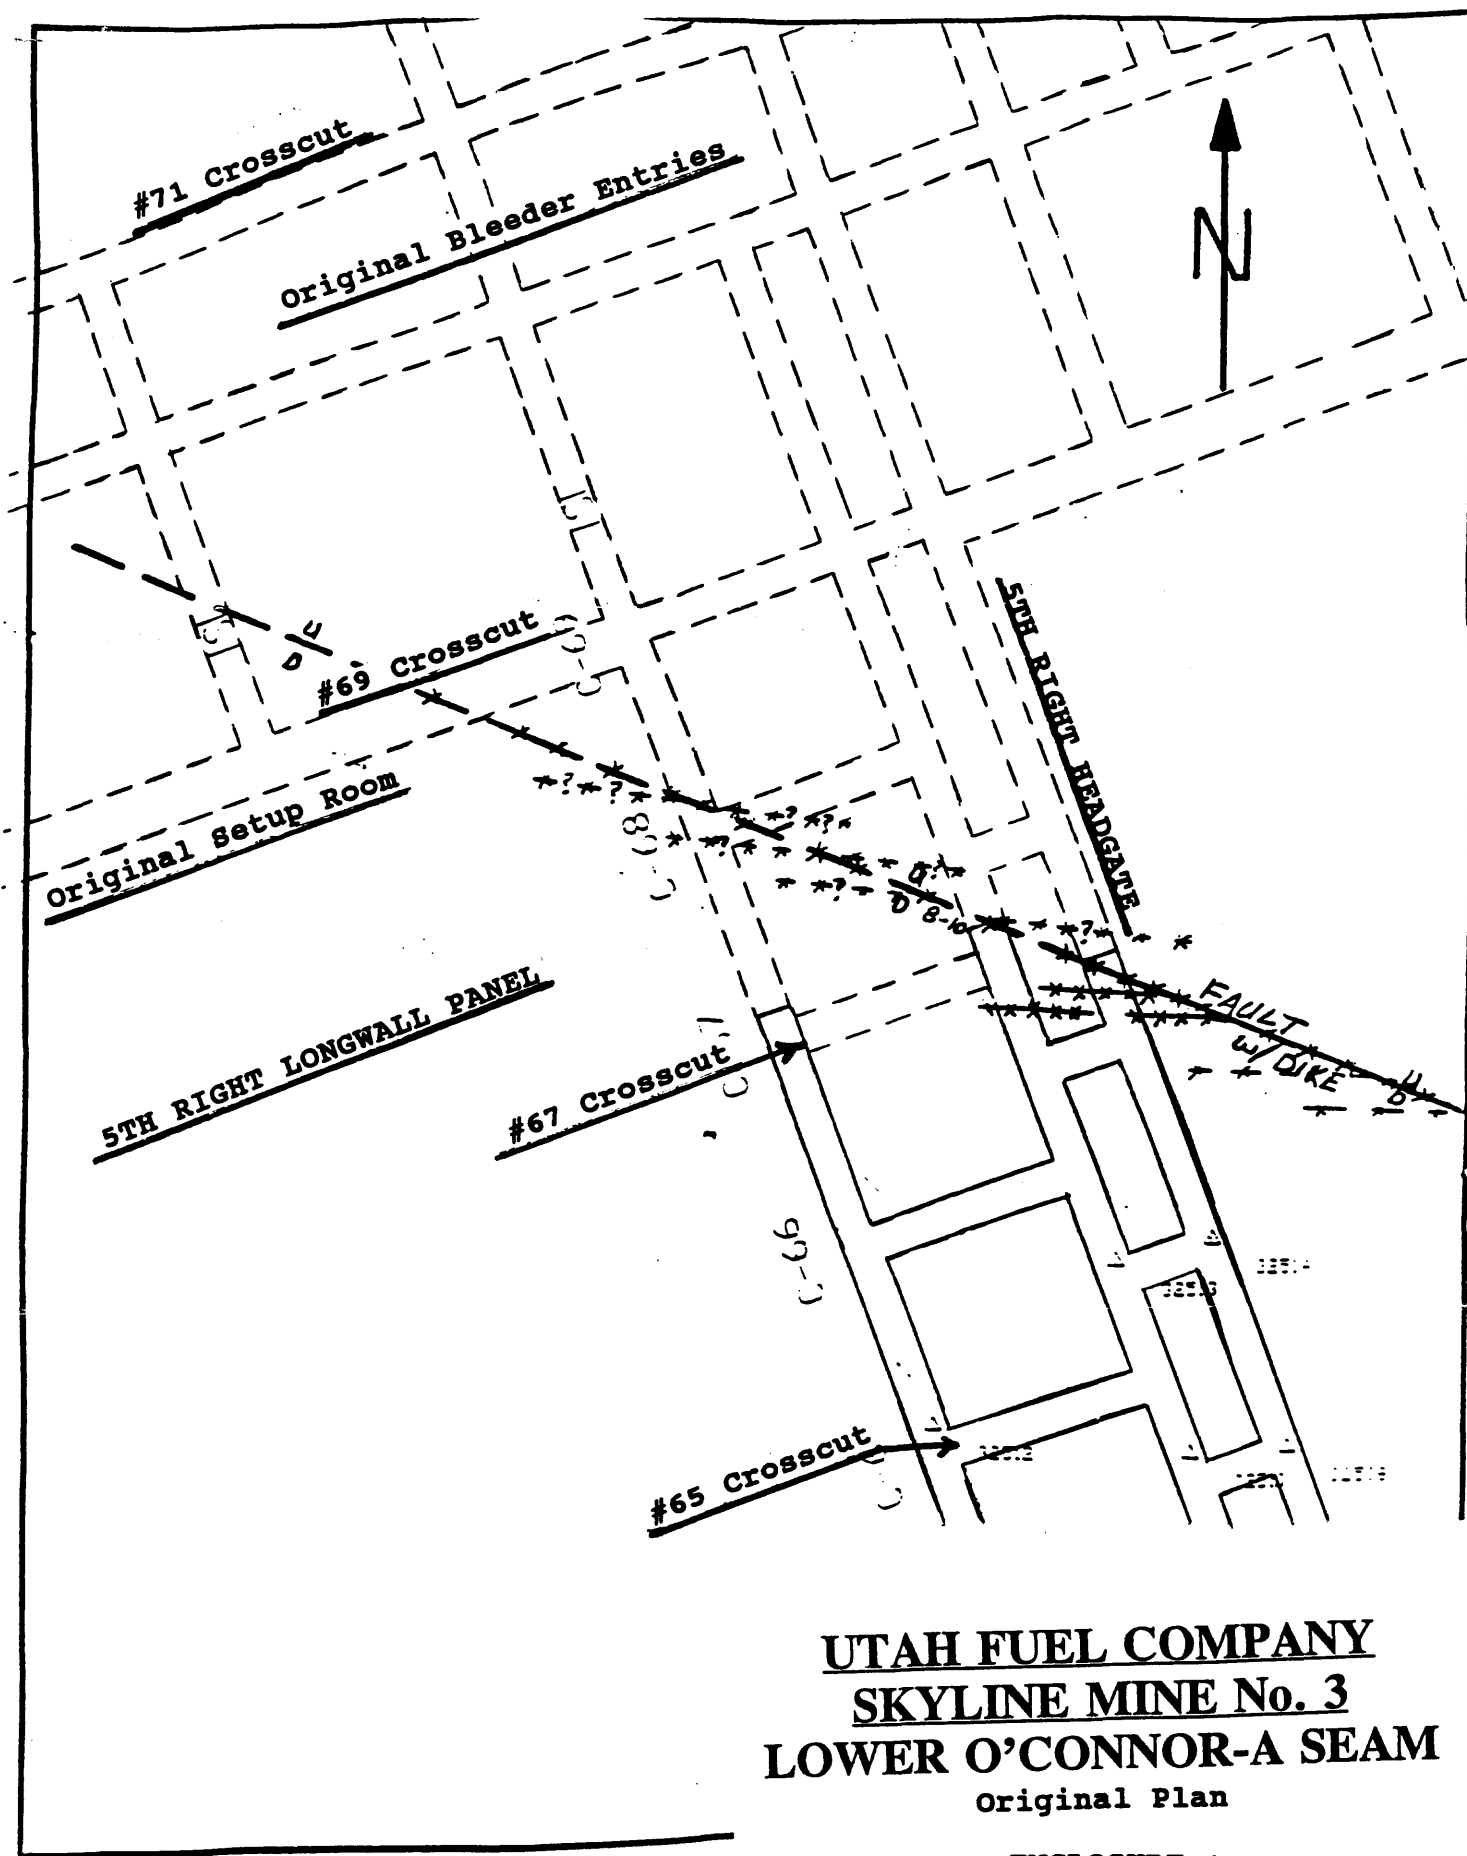
ENCLOSURE 1

The approved mining plan was to develop setup room and bleeder entries for the 5th Right longwall panel between #69 and #71 crosscuts of the 5th Right Headgate (see Enclosure 1). UFC is now proposing to develop the setup room and bleeder entries between #65 and #68 crosscuts. UFC also proposes to mine the block of coal between #68 and #71 crosscuts from the 3rd Right bleeder entries utilizing room-and-pillar mining practices (see Enclosure 2).

According to UFC, the 5th Right Headgate in the Skyline Mine No. 3 has encountered a fault with a highly fractured zone. The fault would cross through the originally planned setup room for the 5th Right longwall panel. Unstable roof and unexpected high stress conditions encountered in the vicinity of this fault preclude the development of the setup room which requires an entry width of 28 feet.

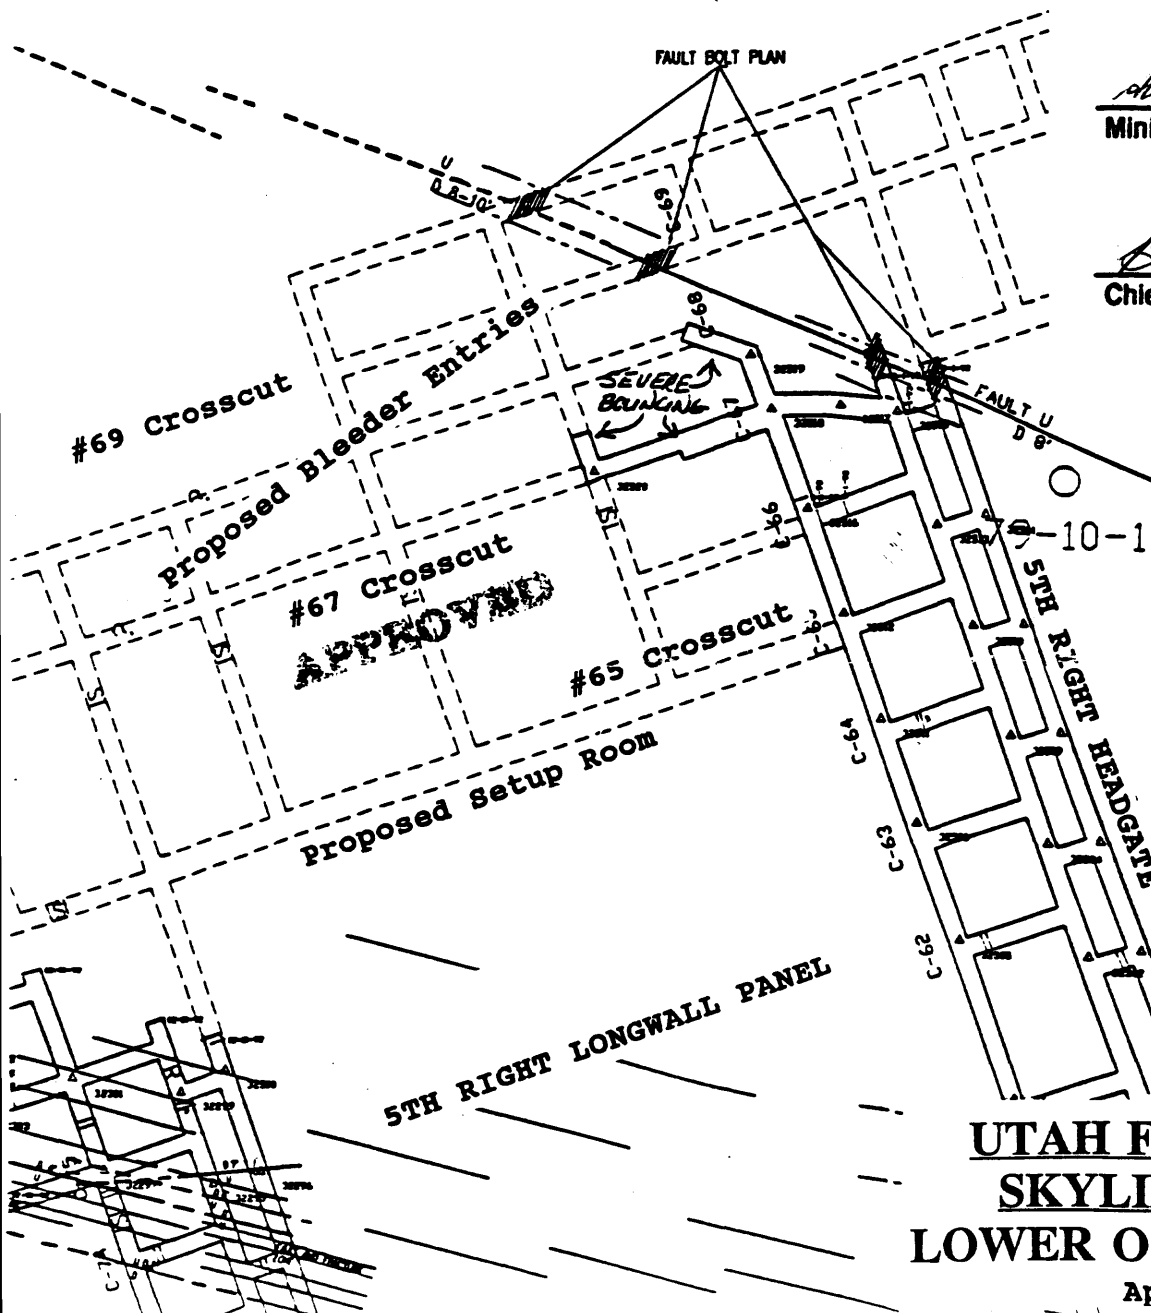
ENCLOSURE 2

The 5th Right Headgate was inspected by the BLM on May 6, 1993. A fault with 8 feet of vertical displacement was observed in the #3 entry at #66.8 crosscut. In this entry, an igneous dike approximately 4 inches thick has merged with the fault. This dike has increased to 2 feet thick in the #2 entry at #67 crosscut and the fault was 20 feet in by the dike. Developing the #1 entry was stopped after intersecting the dike at #67.6 crosscut. Fault gouge had flowed from the ceiling leaving a large cavity with weak roof. Heavy duty strap mats and trusses were added for additional roof support in main entries and intersections.

A second inspection was conducted on May 17, 1993, while UFC was developing a room along the fault line at #67 crosscut. During the inspection, signs of heavy loading in this area were indicated by rib rolling, roof cutters and bent roof bolt baring plates. Severe bouncing also occurred during the inspection.

Based on the BLM's observations in the mine, the fault will intersect the originally planned setup room for the 5th Right longwall panel. Developing the setup room and bleeder entries in the vicinity of this fault could trigger additional bouncing which would seriously endanger employees and mining equipment. In addition, the 28 feet required for the setup room will further de-stabilize the roof. Recovering the remaining reserves in this block with a continuous miner from the 3rd Right bleeder entries will result in maximum coal recovery.

Therefore, the BLM authorizes UFC to develop the setup room and bleeder entries for the 5th Right longwall panel between #65 and #68 crosscuts of the 5th Right Headgate as requested. This confirms the verbal approval given to Utah Fuel Company personnel on May 17, 1993. In addition, UFC will develop (first mining only) the remaining reserves in the block of coal between #68 and #71 crosscuts from the formerly approved 3rd Right bleeder entries by room-and-pillar mining methods. The modified plan will reduce the recoverable coal reserves in this section of the mine by 40,000 tons.
